## INSTALLATION METHOD FOR MAIN STUD KITS Part Number: 234-5802 Application: Chevy Gen V 6.2L (LT1) V8

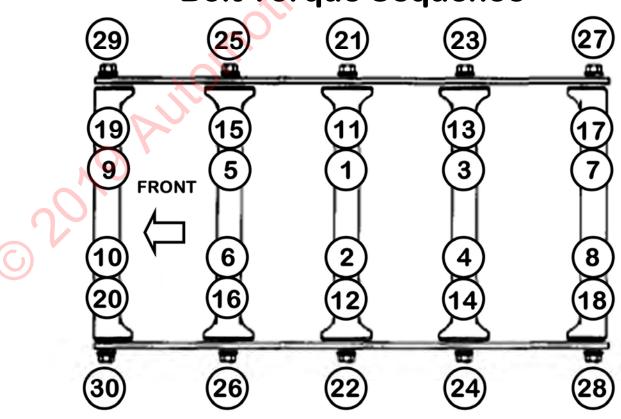
## **Bolt Torque Sequence**

6. Following the manufacturers recommended torque sequence tighten the nuts and bolts in three equal steps to the specifications listed below with ARP ULTRA-TORQUE FASTENER ASSEMBLY LUBRICANT.
